## PROJECT SPOTLIGHT:

### Ontario Ministry of Transportation - Bass Lake Bridge Replacement Project Lessard Welding 18.3 Span Modular Bridge - 2009

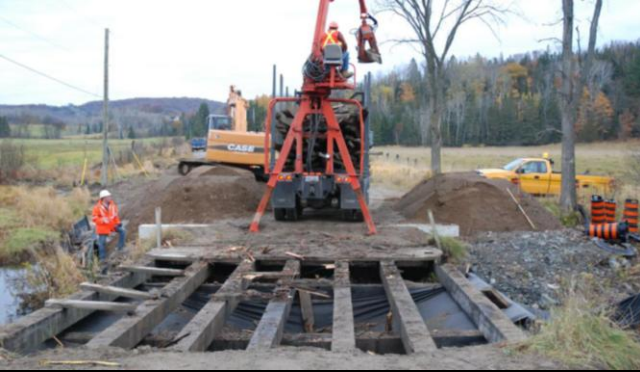
**Photo 1:** Logging Truck, together with Case track excavator remove decking of existing bridge, exposing decayed 300mm timber stringers.

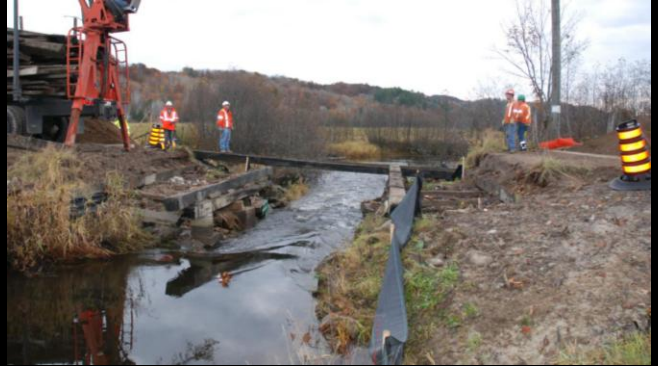
**Photo 2:** Upstream face of Bass Lake Creek Crossing. New concrete bearing substructure is visible upper right. Old stringers provide temporary for access for construction crew.

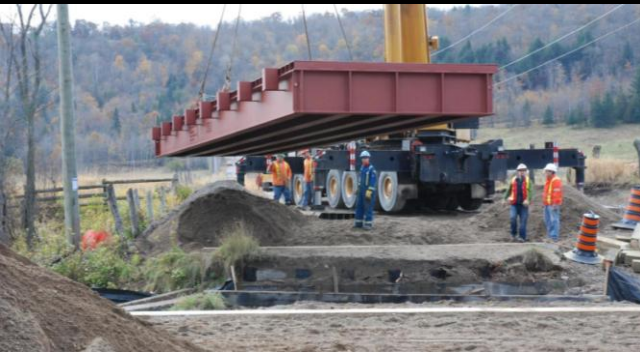
**Photo 3:** Section 1 of new 18.3m span Lessard Modular Bridge is hoisted by 90 ton crane into position. New concrete bearing visible in foreground.

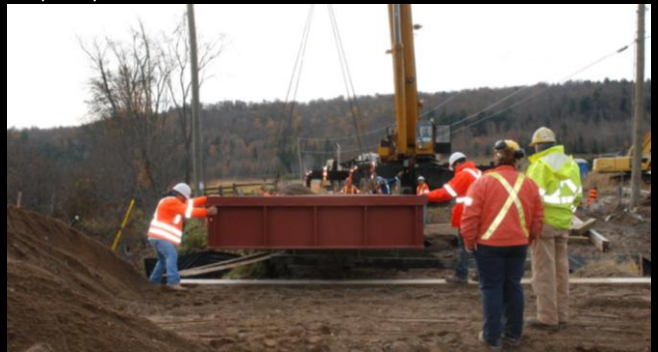
**Photo 4:** Section 1 (upstream face) is lowered carefully into position. Concrete bearing swept clear of debris prior to final section location.

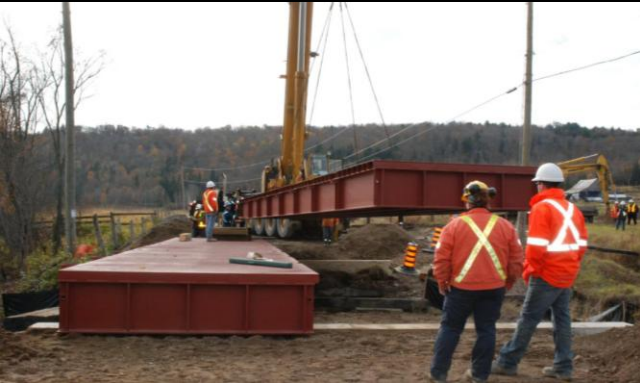
**Photo 5:** Section 1 (upstream face) in final position, Section 2 of new 18.3m span Lessard Modular bridge is lowered into matching position.

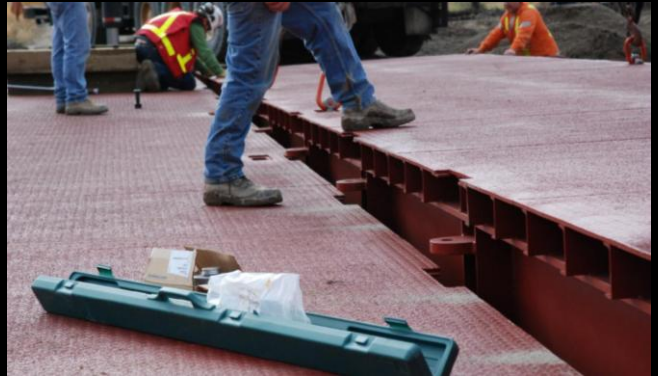
**Photo 6:** Construction forces guide the tie down plates of Section 2 to the receiving plates on Section 1 and connect using structural bolts.

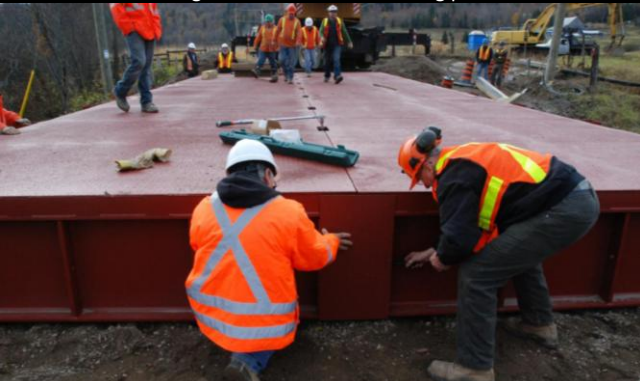
**Photo 7:** MTO crew and construction forces attach soil retention plates following the connection of section 1 to section 2 of the bridge.

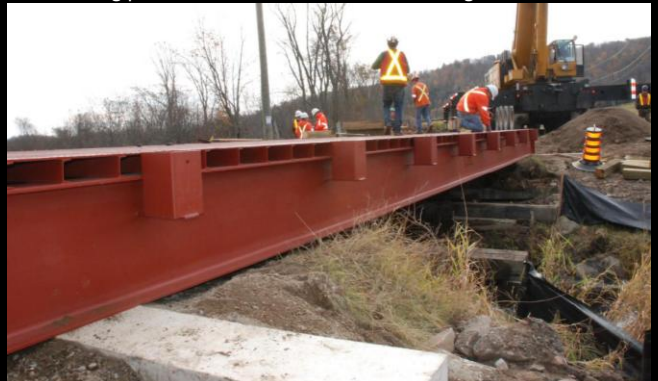
**Photo 8:** Downstream Face of new 18.3m span Lessard Modular Bridge.
