## PROJECT SPOTLIGHT:

### Municipality of West Nipissing - Municipalité de Nipissing Ouest - DUCK CREEK (Bridge 002) Replacement Lessard Welding 15.2 m Span x 4.67 m Wide Modular Bridge - 2018

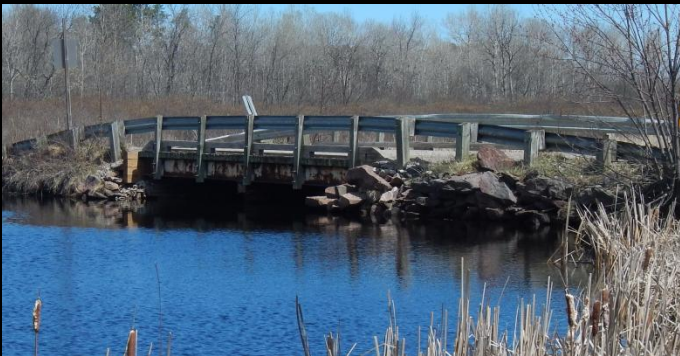
**Photo 1:** Upstream face of existing 9.6m span stringer bridge looking North-easterly.

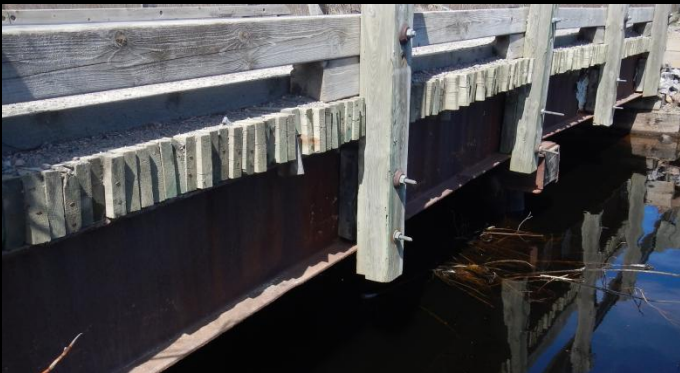
**Photo 3:** Downstream face of existing 9.6m span stringer bridge. Centre pile cap visible at midpoint of span. Stringer bending/distortion is also visible.

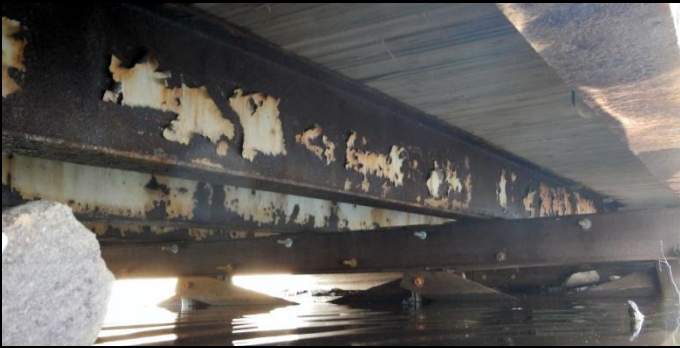
**Photo 5:** Photo showing centre pile cap and batter piles under mid span of existing bridge. Note poor condition of bridge stringers and limited clearance.

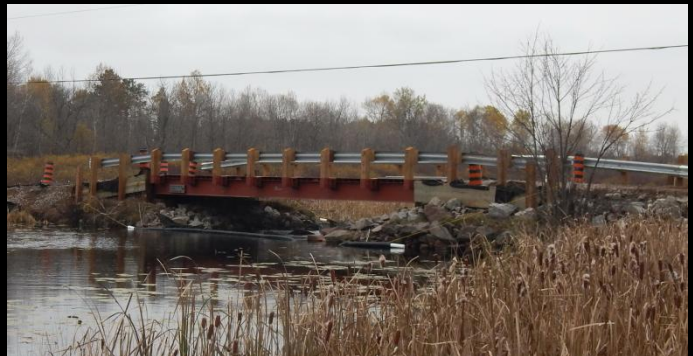
**Photo 2:** Upstream face of new 15.2m span Lessard Modular bridge looking North-easterly. Additional clearance below bridge visible.

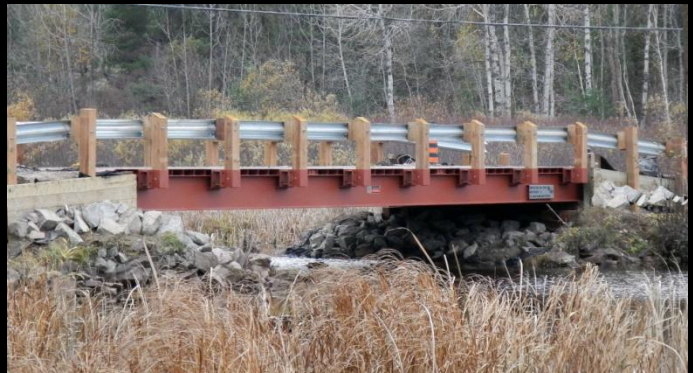
**Photo 4:** Downstream face of new 15.2m span Lessard Modular bridge. Pile cap removed as part of old bridge removal/new bridge installation.

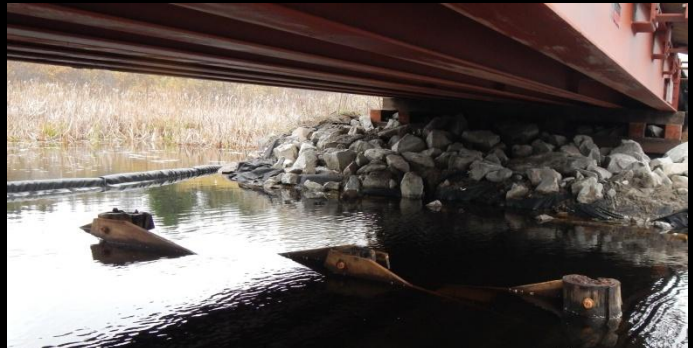
**Photo 6:** Photo showing the clearance under the new 15.2m span Lessard Modular bridge. Remnants of batter piles and new substructure are visible.

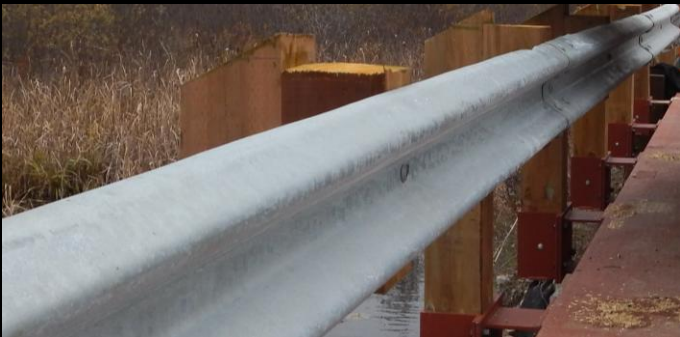
**Photo 7:** Post pocket extensions on the new 15.2m span Lessard Modular bridge allow standard OPSD Guide Rail installation (steel rail, post and post block) without encroaching onto the bridge deck surface.

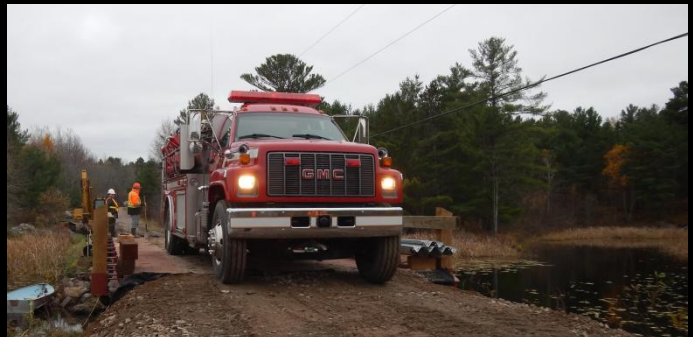
**Photo 8:** Municipal fire truck (Full of water) leaves its temporary post on the south side of the bridge (inaccessible during construction) while crew complete installation of new timber posts & steel guide rail.
